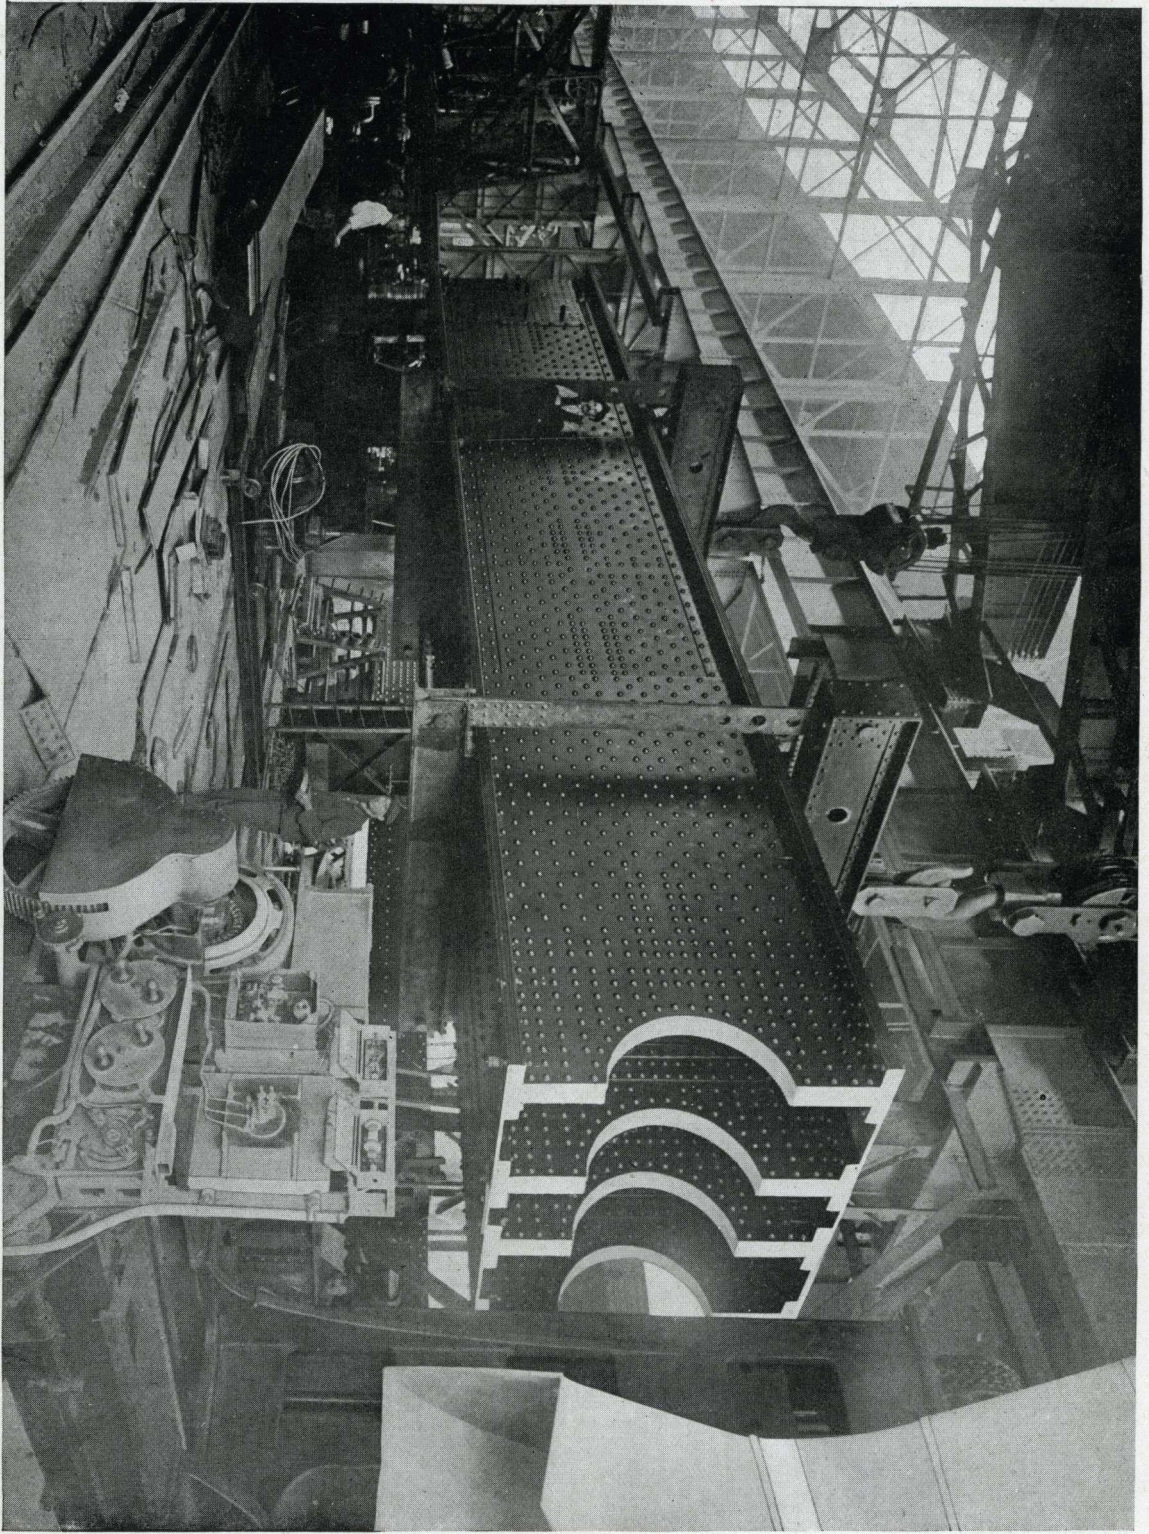
11—An end section of the bottom chord being removed from the vertical planing machine

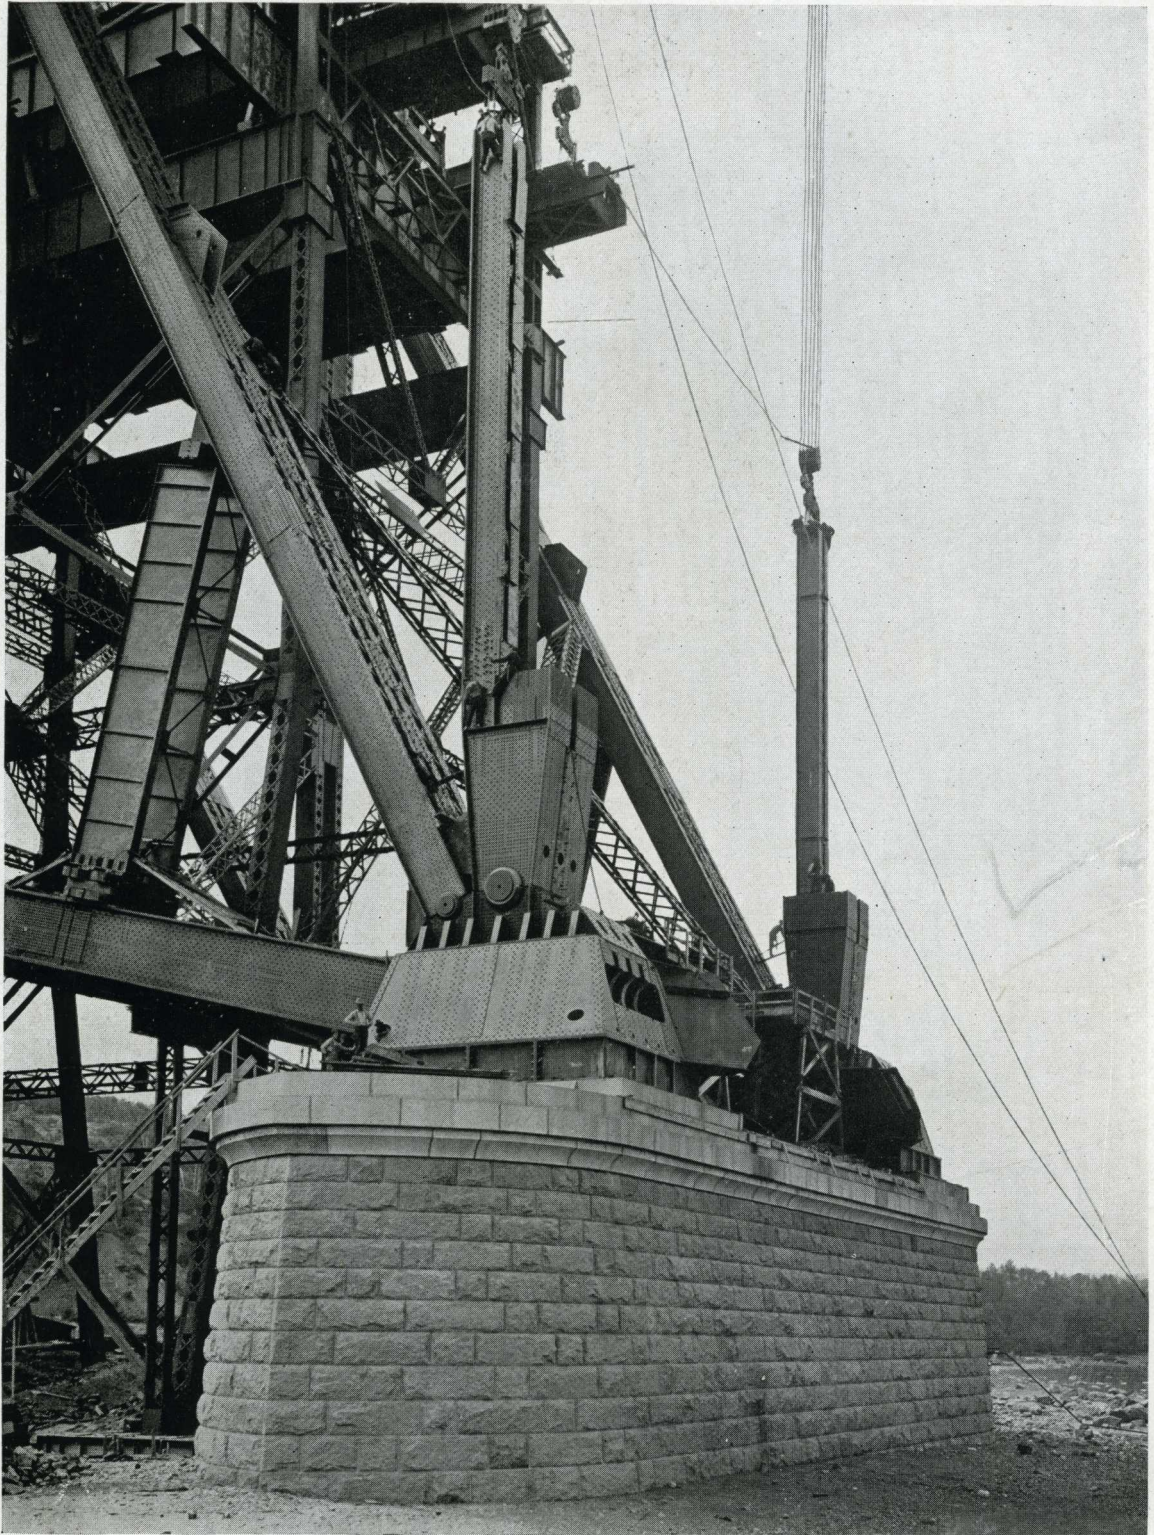
23—Starting the erection of the anchor arm web system
